网卡固件升级工具用户手册

2024 年 4 月

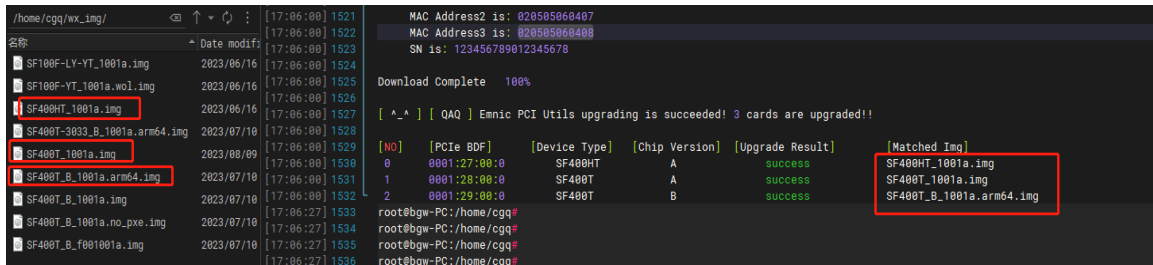
a) wx_img 目录下均有与网卡匹配的固件，烧录成功结果如下

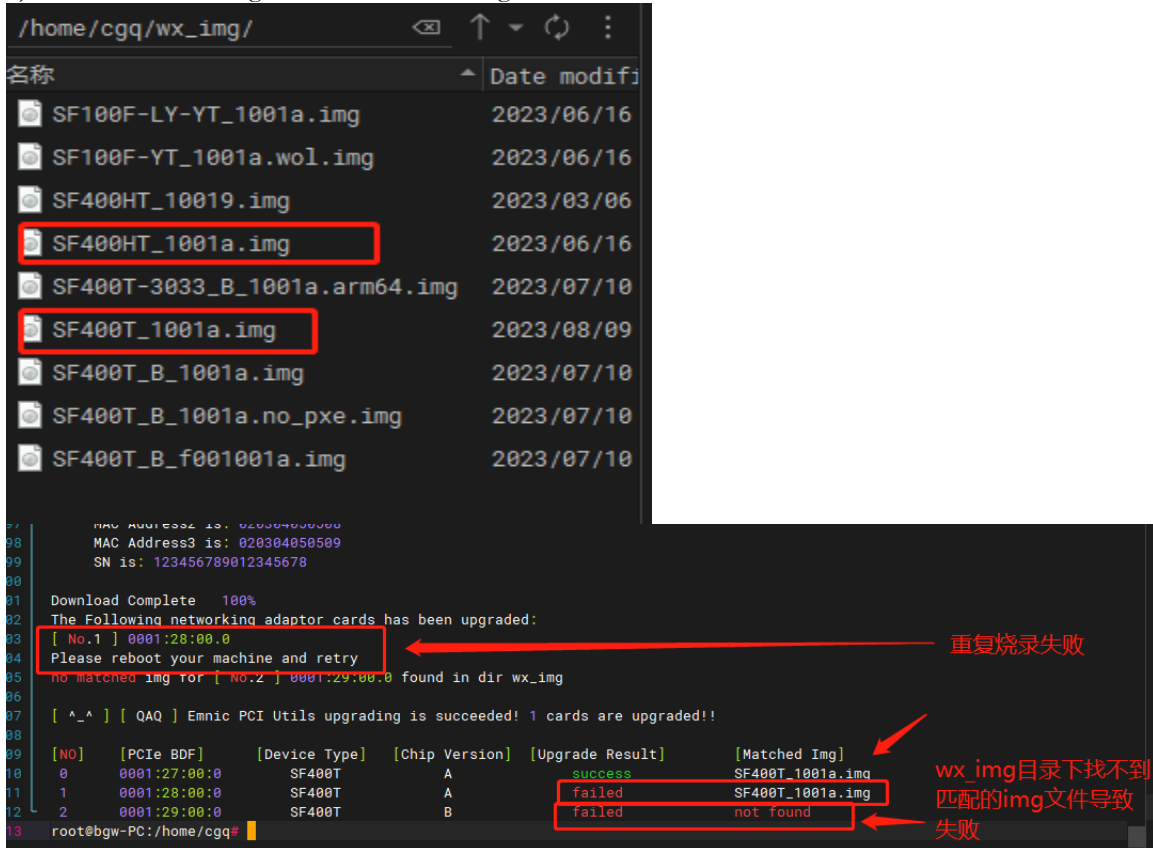
b) 重复烧录, wx_img 目录中没有对应 img, 都会报错, 报错信息如下

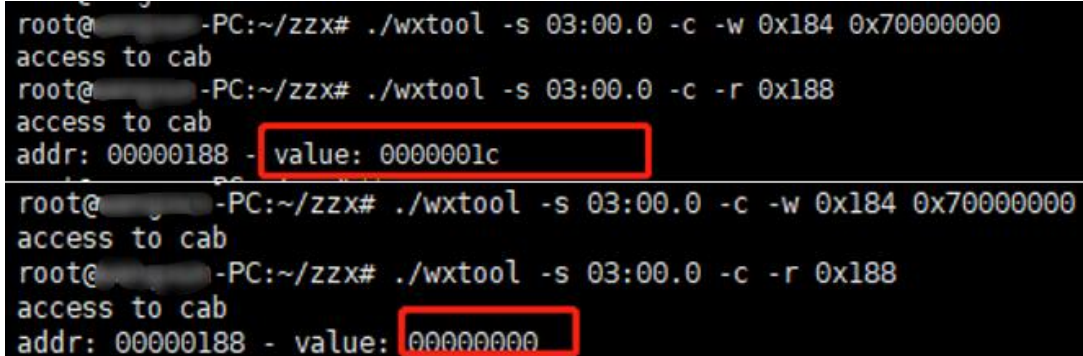
命令:

```
./wxtool -s 84:00.0 -c -w 0x184 0x70000000  
./wxtool -s 84:00.0 -c -r 0x188
```

```
root@-PC:~/zzx# ./wxtool -s 03:00.0 -c -w 0x184 0x70000000  
access to cab  
root@-PC:~/zzx# ./wxtool -s 03:00.0 -c -r 0x188  
access to cab  
addr: 00000188 - value: 0000001c  
root@-PC:~/zzx# ./wxtool -s 03:00.0 -c -w 0x184 0x70000000  
access to cab  
root@-PC:~/zzx# ./wxtool -s 03:00.0 -c -r 0x188  
access to cab  
addr: 00000188 - value: 00000000
```

如图，value 值若为 0000001c，则表示此时为加锁状态；value 值若为 00000000，则表示此时为解锁状态。

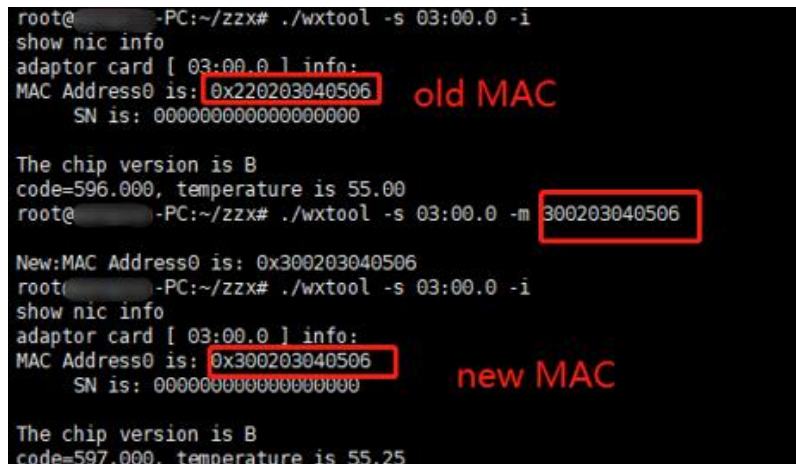
2.4.3 【-s -m】：修改网口 MAC 地址

命令:./wxtool -s 02:00.0 -m 220203040506

```
root@-PC:~/zzx# ./wxtool -s 03:00.0 -i  
show nic info  
adaptor card [ 03:00.0 ] info:  
MAC Address0 is: 0x220203040506 old MAC  
SN is: 00000000000000000000

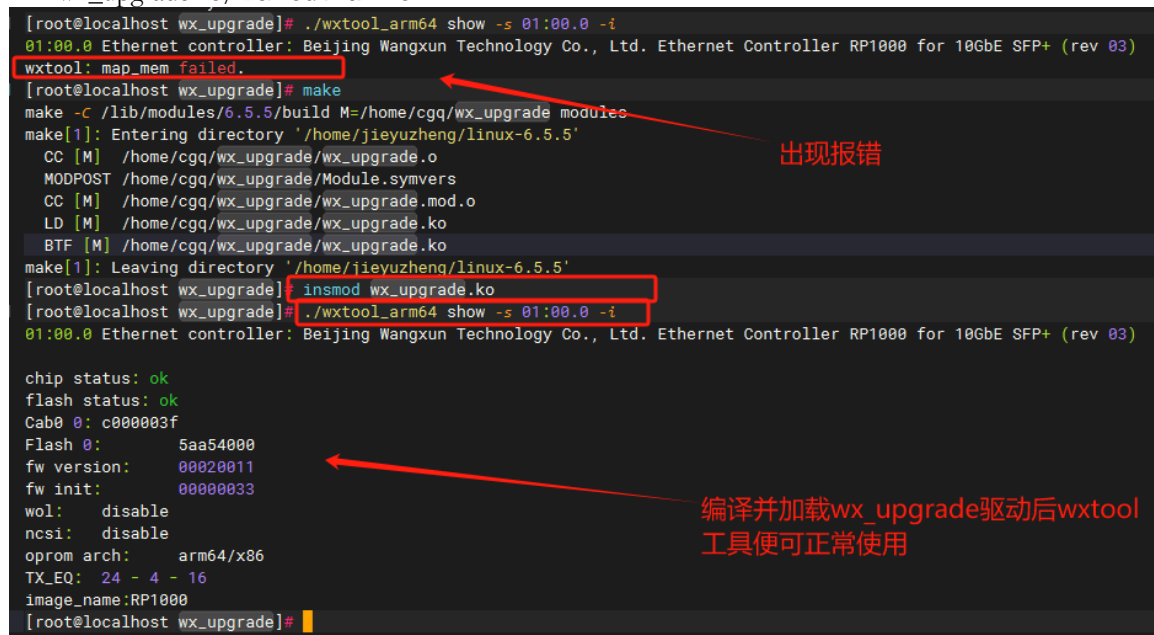
2.5.10 arm架构centos系统下执行wxtool报错wxtool: map_mem failed 解决方法：

1. 使用 wxtool-3.7.4 版本
2. 使用附带的 wx_upgrade 驱动或 mem 驱动源码在所用系统 make 编译，insmod wx_upgrade.ko/insmod mem.ko

```
[root@localhost wx_upgrade]# ./wxtool_arm64 show -s 01:00.0 -i
01:00.0 Ethernet controller: Beijing Wangxun Technology Co., Ltd. Ethernet Controller RP1000 for 10GbE SFP+ (rev 03)
wxtool: map_mem failed.
[root@localhost wx_upgrade]# make
make -C /lib/modules/6.5.5/build M=/home/cgq/wx_upgrade/modules
make[1]: Entering directory '/home/jieyuzheng/linux-6.5.5'
CC [M] /home/cgq/wx_upgrade/wx_upgrade.o
MODPOST /home/cgq/wx_upgrade/Module.symvers
CC [M] /home/cgq/wx_upgrade/wx_upgrade.mod.o
LD [M] /home/cgq/wx_upgrade/wx_upgrade.ko
BTF [M] /home/cgq/wx_upgrade/wx_upgrade.ko
make[1]: Leaving directory '/home/jieyuzheng/linux-6.5.5'
[root@localhost wx_upgrade]# insmod wx_upgrade.ko
[root@localhost wx_upgrade]# ./wxtool_arm64 show -s 01:00.0 -i
01:00.0 Ethernet controller: Beijing Wangxun Technology Co., Ltd. Ethernet Controller RP1000 for 10GbE SFP+ (rev 03)
